Technical Circular

No.: 036/2022

Subject: USCG Marine Safety Alert 04-22 Reg. Handhold in Gateway Embarkation Arrangements.

Safety Alert 04-22

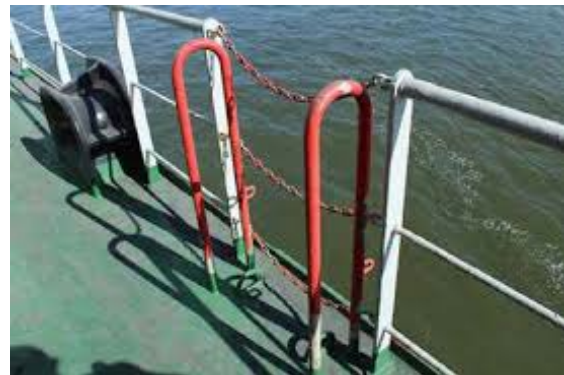
SOLAS 2004 (Consolidated) is clarified by IMO Resolution A.1045 (27) to indicate that each handhold in a gateway arrangement should be rigidly secured to the ship's structure at or near its base (Figure 3).

Figure 3: Handholds rigidly secured to the vessel structure at their base.
