Technical Circular

No.: 004/2023

Subject: Rescue Boat Lifting Arrangement Failure.

MARINE SAFETY ADVISORY No. 03-23

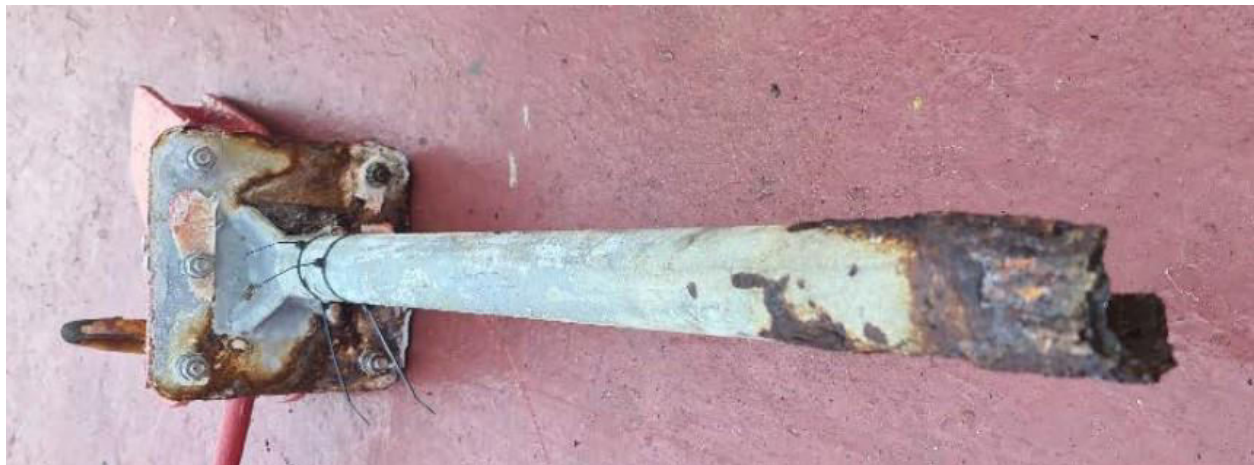
During the investigation, it was found that significant deterioration of the lower end of the support post for the release hook had occurred due to corrosion (see Figure 1). The lower side of the release hook support post was below the deck and only visible following removal of a portable fuel tank.

Figure 1: Photo of the rescue boat release hook support structure taken after the incident, showing significant deterioration of the post.

The Jiangyin Wolong model “JY40KR” rescue boat involved in this incident was manufactured in 2008. No defects or issues were noted when the boat was tested in 2019 or in November 2022 during the last annual inspection.

The Administrator recommends that owners, operators, and Masters of RMI-registered vessels fitted with Jiangyin Wolong “JY40KR” rescue boats thoroughly inspect the release hook and entire support post, including mounting hardware, for signs of deterioration.

Additionally, the Administrator recommends that owners, operators, and Masters ensure monthly inspections of life-saving appliances include thorough inspections of lifting arrangements for all onboard lifeboats and rescue boats with specific emphasis on hidden or hard to access components.
